Confidential Inspection Report

LOCATED AT:
123 Anywhere St
Sandpoint, Idaho 83849

INSPECTED ON:
Sunday, August 4, 2019

Inspector, Robert Lavala Idaho & Montana Certified
Great Northwest Inspections, LLC

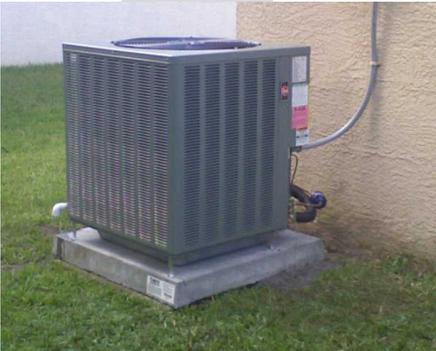
Type of system: Heat pump

Location of equipment: Single package system

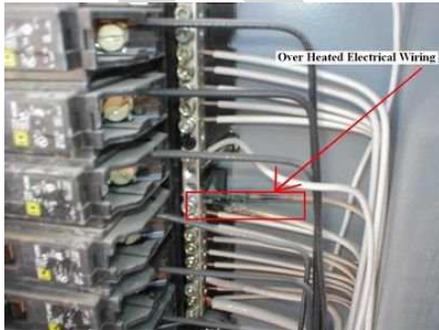
MAIN CIRCUITRY

There is evidence that wiring has been overheated in the past. The affected wiring and insulation is still serviceable. No conditions likely to cause overheating were observed, suggesting the cause for this condition has already been addressed.

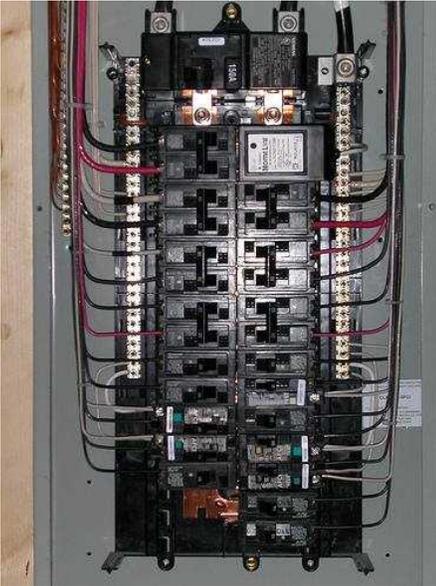
BRANCH CIRCUITRY

The accessible branch circuitry was examined and appeared properly installed and in serviceable condition.

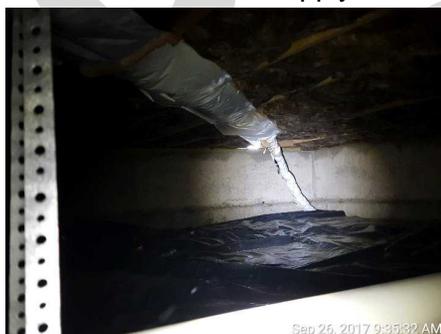
WATER SHUTOFF LOCATION

The domestic water supply main shut-off valve is on the front wall in the underbuilding crawl space.

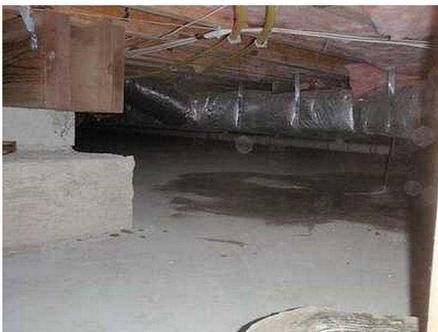
MOISTURE

We observed evidence of minor seepage at the crawl space entrance. There was no visible damage observed resulting from this moisture condition present to date. We recommend the area be monitored for additional seepage and corrective measures taken if necessary.

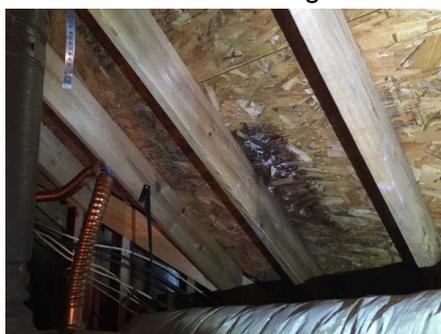
LEAK EVIDENCE

WARN There are water stains on the underside of the sheathing and the rafters. These are indications of old leaks. No current leakage is evident or suspected. No action is indicated.

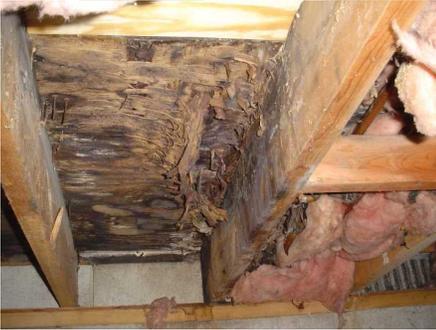
SUBFLOORING

WARN **UPGR** Generally, the subflooring is in good condition. However, the subfloor beneath the master bathroom is damaged. We recommend the subflooring be repaired and all damaged material replaced.

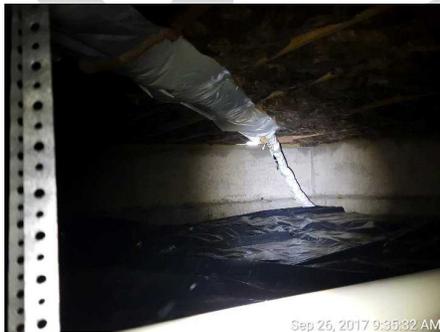
PLUMBING

The domestic water supply main shut-off valve is on the front wall in the underbuilding crawl space.
